## Treatment and Interpretive Recommendations

## **Phase 1 – Stabilization of the Existing House:** **Refer to the Phase 1 Treatment Drawings and Product Cut Sheets in the Appendix**

### **Architectural Treatment Recommendations (Figures 1-18):**

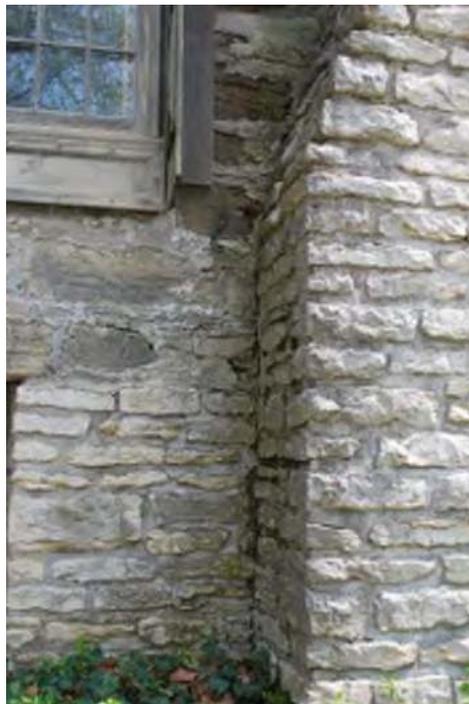
Figure 1. Stone foundation of log house, west elevation. (SRJA 2104)

- *Main House:* At the stone foundation of the log home, remove inappropriate mortar at the stone foundation and repoint. Modern Type 'N' mortar should be used. Care shall be taken to match the existing mortar color, aggregate, and tooling. (Figure 1)

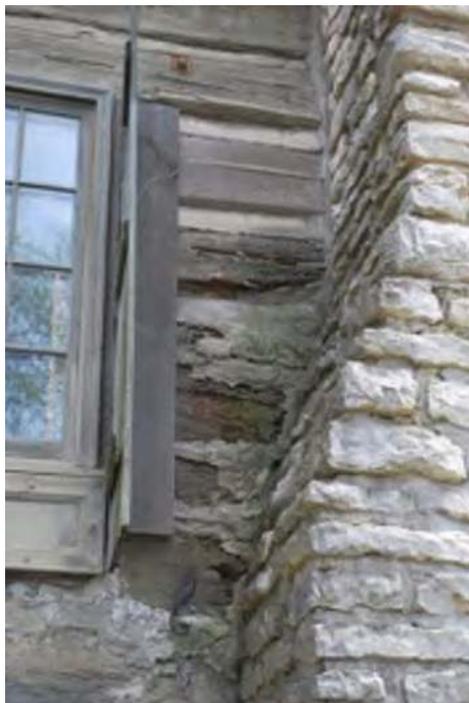
Figure 2. Detail of the deteriorated logs on the west wall adjacent to the stone chimney. This is due to poor construction detailing as the stone chimney abuts the logs, west elevation. (SRJA 2014)

- *Main House:* Replace the deteriorated logs on the west and north elevations of the existing log house. When the deteriorated logs abutting the chimney are replaced, a new flashing detail should be installed to prevent deterioration of the replacement logs. This work will require significant shoring and will likely require removal and replacement of the interior wood paneling at the west wall. This may also include the temporary removal of the two west windows for access to the deteriorated logs. (Figure 2)

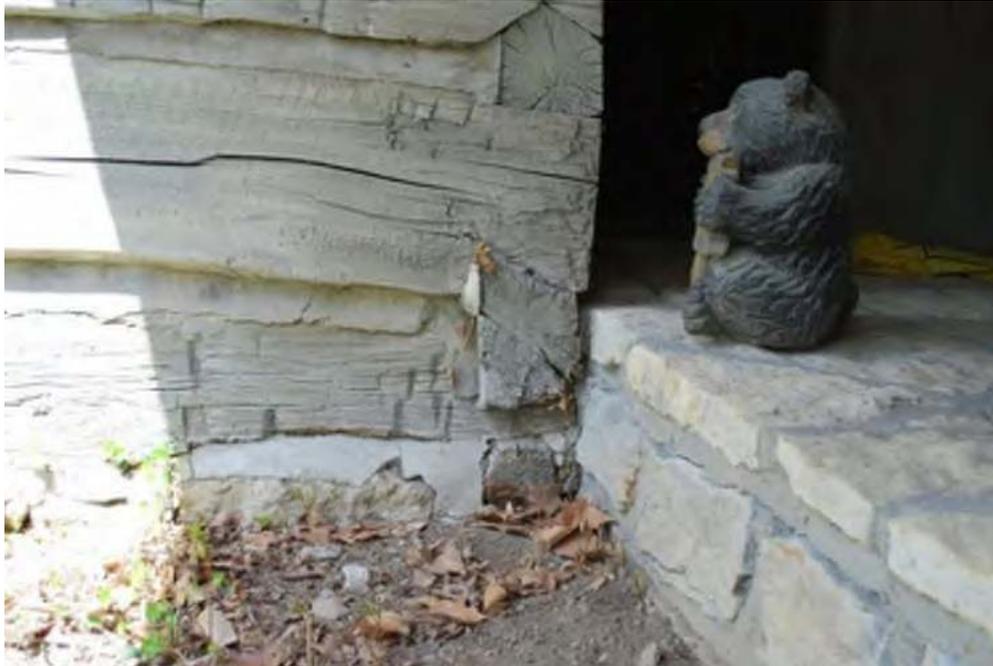
*Figure 3. Sill log is buried below grade.  
The soil needs to be re-graded to at least 6" below the bottom of the sill log. (SRJA 2013)*

- *Main House:* Remove existing Portland cement daubing that is damaging the historic logs. Perform chinking/daubing repairs.
- *Main House:* Re-grading is required on the south elevation of the log house. The soil shall be removed to no less than 6 inches below the bottom of the sill log. This minimum soil distance is typical for the entire house. (Figure 3)

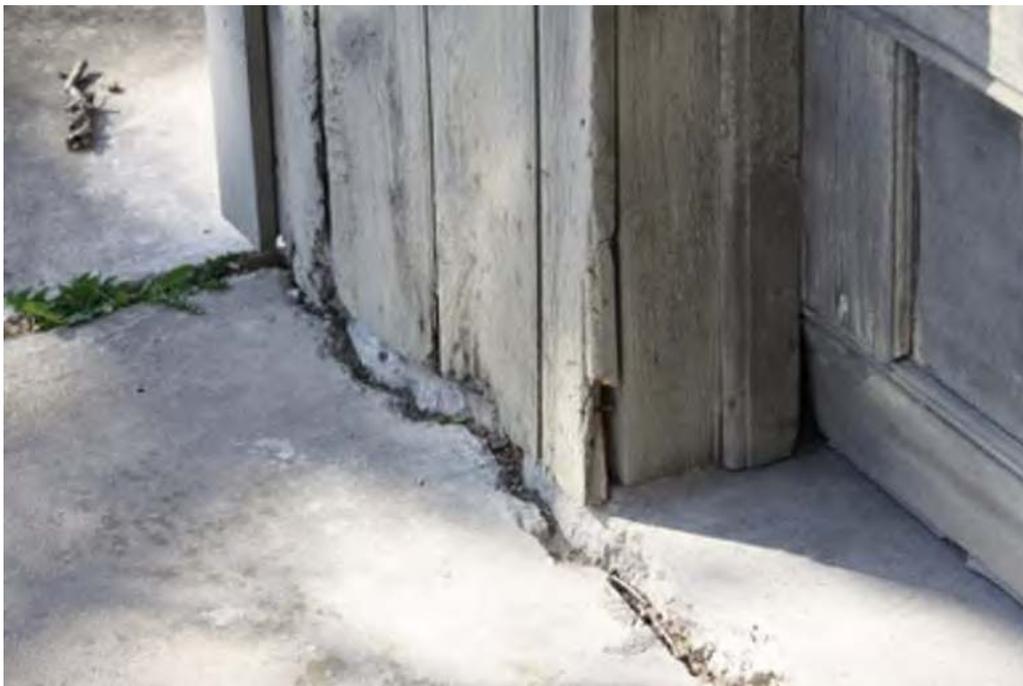
*Figure 4. Detail of deteriorated garage trim and open cracks in the concrete drive. (SRJA 2013)*

- *Roof:* Install drip edges along all roofs that are adequate to shed water.
- *Garage:* Replace deteriorated wood trim and deteriorated fascia. Paint new trim and fascia, and touch-up paint on existing wood trim and fascia to prevent wood rot. (Figure 4)

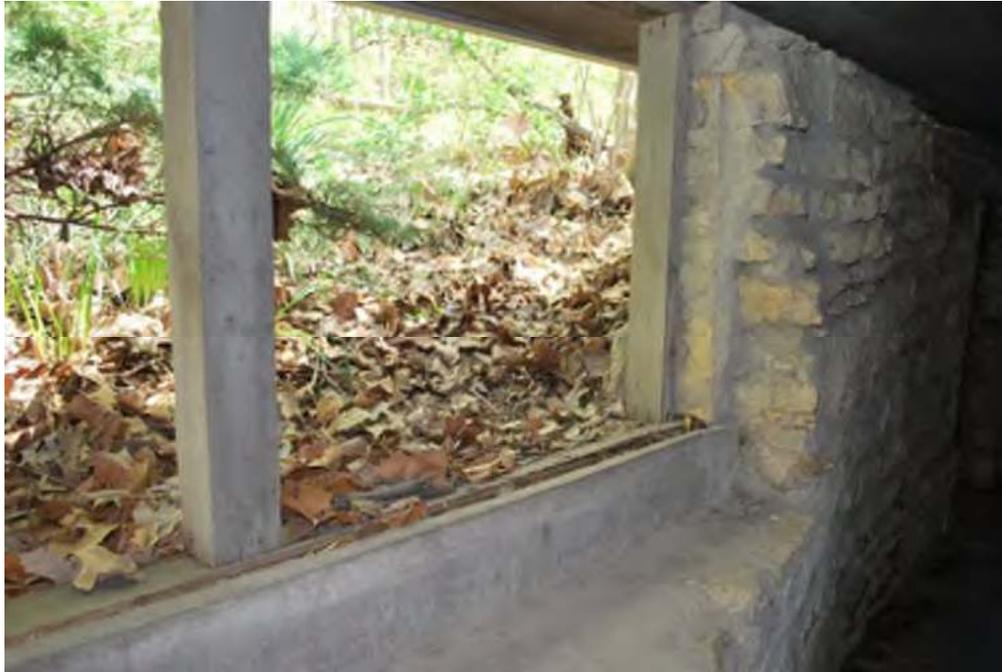
*Figure 5. Rear breezeway east wall deteriorated wood framing. (SRJA 2013)*

- *Garage:* Install sealant in the cracks in the concrete floor. Monitor for future movement.
- *East Covered Stone Porch:* Repair and paint wood deterioration along the east wall where it abuts the stone foundation. Paint new patch to prevent future wood rot. (Figure 5)

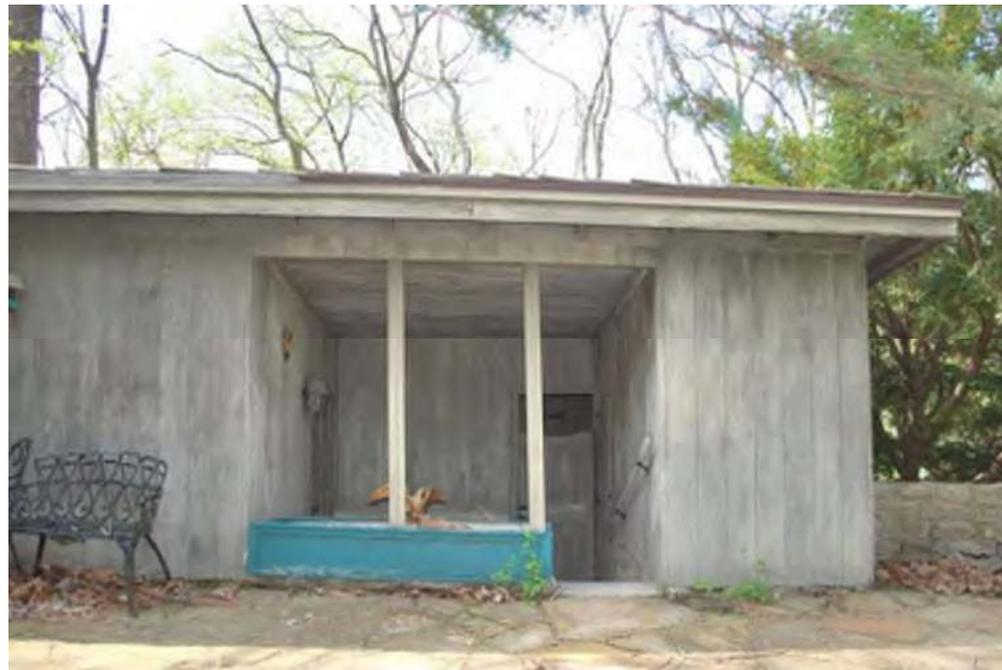
*Figure 6. Rear stone patio & east covered porch. Note the wood planter box is deteriorated. (SRJA 2013)*

- *East Covered Stone Porch:* Install replacement wood or metal upper cistern lid at east wall.
- *Covered Stone Porch:* Repair wood planter box separating the covered porch area from the stone patio. (Figure 6)

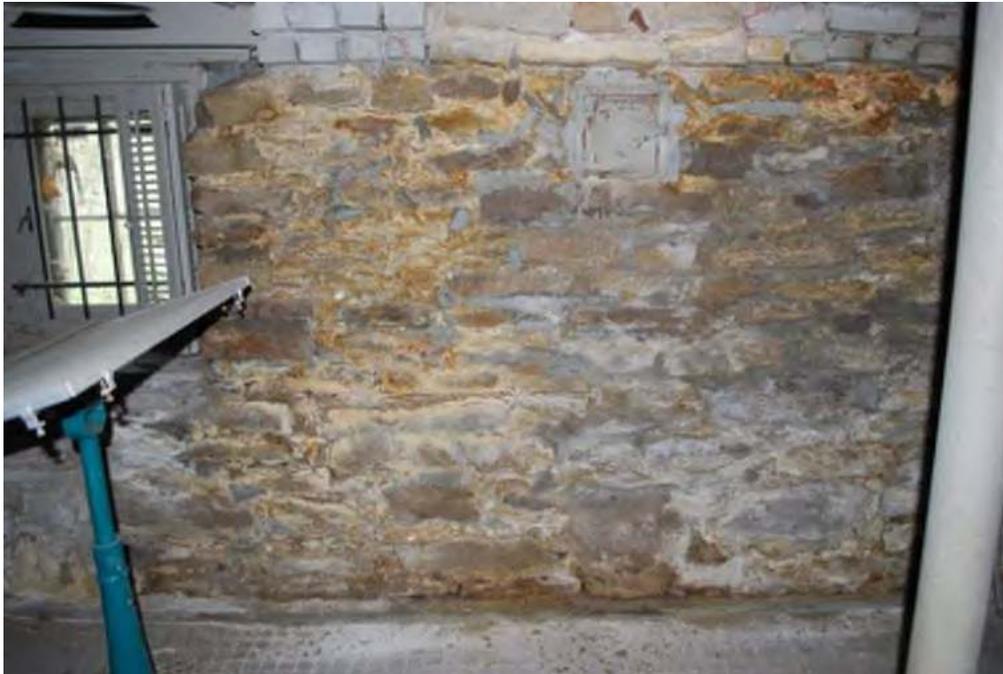
Figure 7. West stone foundation wall in Basement Room 001 to be thoroughly cleaned. (SRJA 2013)

- *Basement 001*: West stone foundation wall to be thoroughly cleaned, all biological growth should be removed and the wall should be checked for deteriorated mortar. Repoint, as required. Spot repoint wall at door into basement. (Figure 7)

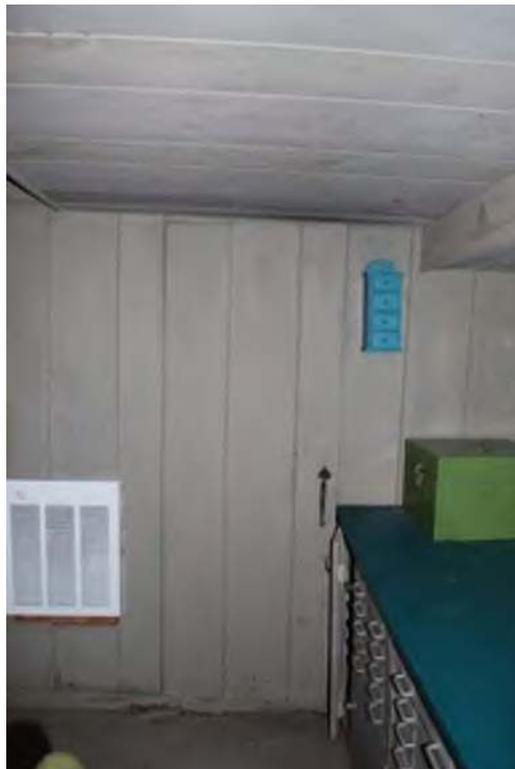
Figure 8. Deteriorated wood partition wall – Door to the storage room that does not fully open. (SRJA 2013)

- *Basement*: Repair Door 002/A so that door properly opens and closes. (Figure 8)
- *Bathroom 003*: Replace damaged wood cabinet doors with in-kind material.

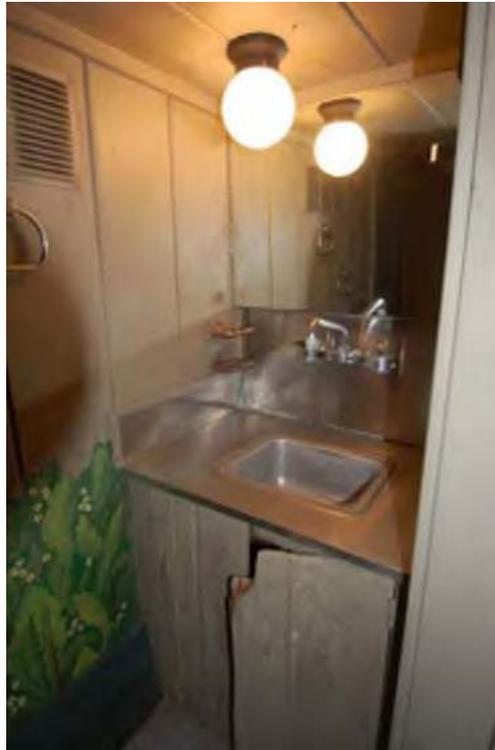
Figure 9. Bathroom 003: Damaged wood cabinet door and stainless steel counter. (SRJA 2015)

- *Bathroom 003*: Remove calcium and lime deposits from stainless steel counter and backsplash. Remove rusted soap dishes to the left of bathroom sink and patch holes. (Figure 9)

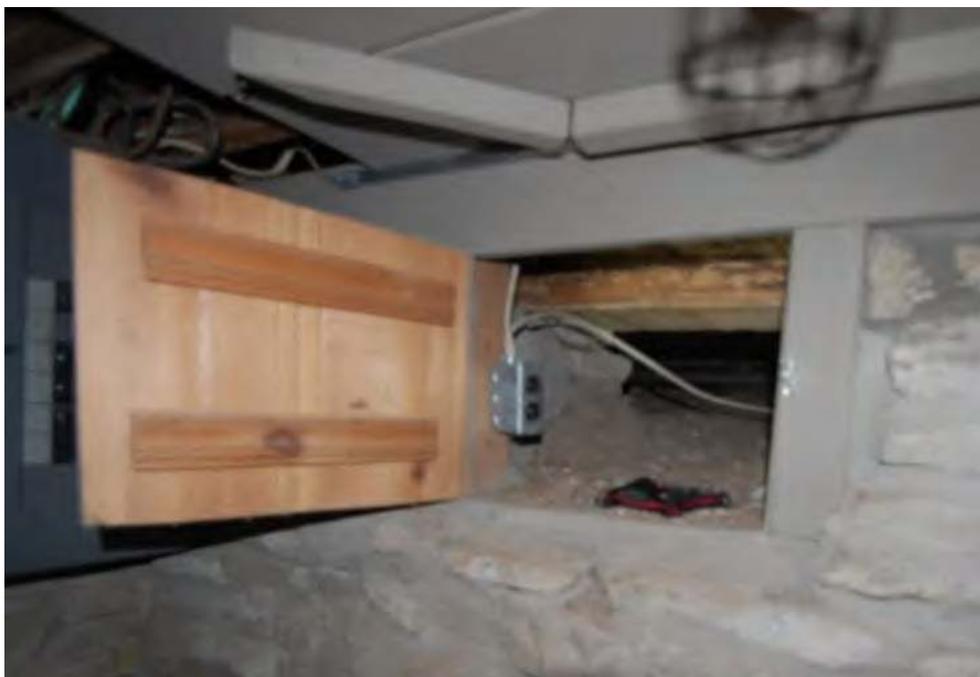
Figure 10. Crawl Space Door that needs weatherstripping. (SRJA 2015)

- *Bathroom 003*: Steam clean existing tile floor and regROUT where necessary.
- *Basement*: Install weatherstripping at Door 004/B. (Figure 10)
- *Crawl Space*: Coordinate new ventilation in Crawl Space with Mechanical Recommendations below. Investigate potential for installation of a vapor barrier throughout the crawl space, as well as insulating the first floor joists.

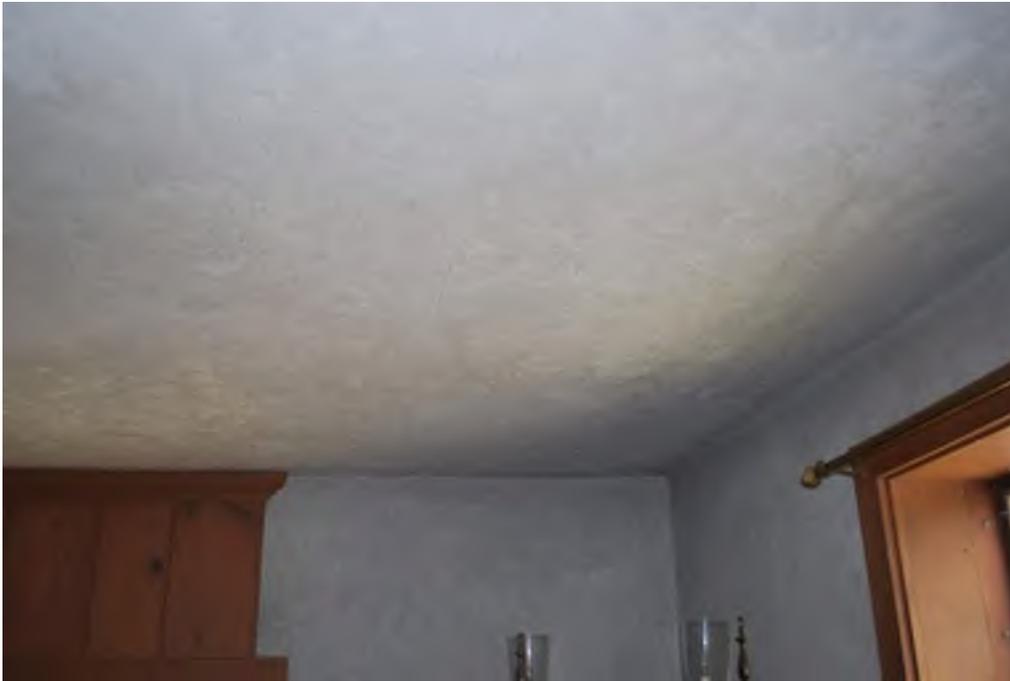
*Figure 11. Living Room 106: Damaged plastered ceiling. (SRJA 2015)*

- *Hallway 006*: Steam clean existing tile floor and regROUT where necessary.
- *Living Room 106*: Permanently disconnect integral radiant heating system located in the ceiling. Remove damaged plaster ceilings and replace with gypsum board. Skim coat gypsum board ceiling to have a similar look to the existing plaster ceiling and paint. (Figure 11)

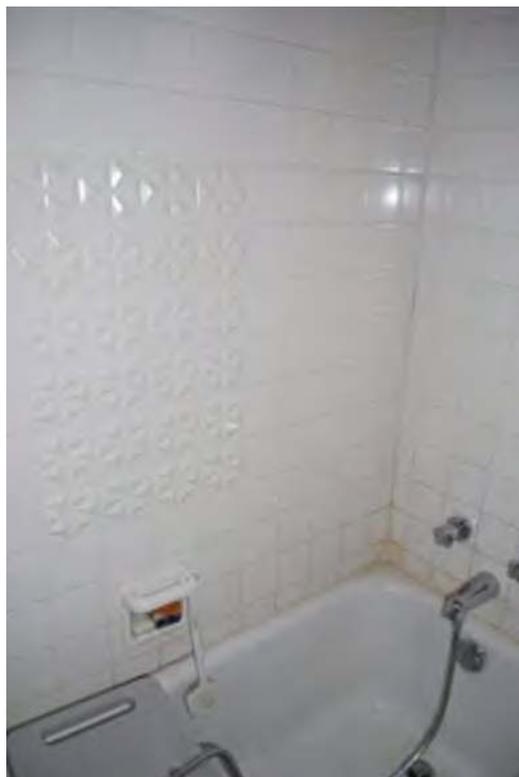
*Figure 12. Bathroom 105: Bathroom tub/shower. (SRJA 2013)*

- *Bathroom 105*: Steam clean existing tiles on shower, walls and floor. Re-grout and caulk where necessary. (Figure 12, Figure 13)
- *Breakfast Nook 107*: Permanently disconnect integral radiant heating system located in the ceiling. Remove damaged plaster ceilings and replace with gypsum board. Skim coat gypsum board ceiling to have a similar look to the existing plaster ceiling and paint. (Figure 14)

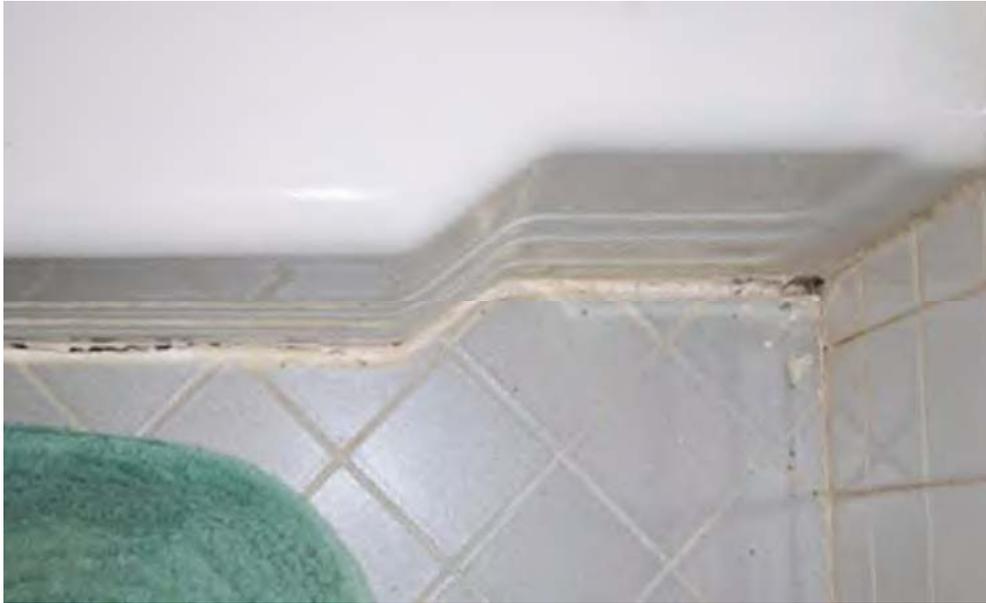
Figure 13. Bathroom 105: Bathroom grout and caulking deterioration. (SRJA 2013)

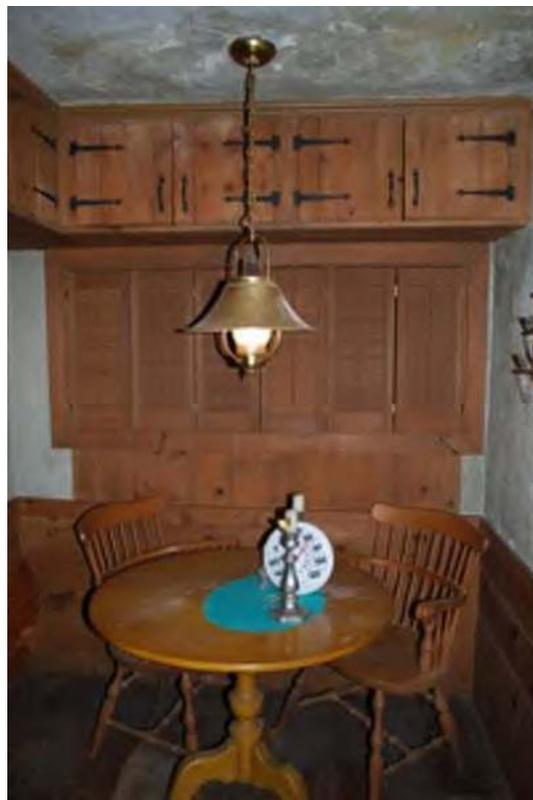
Figure 14. Breakfast Nook: Note the significant plaster damage to the ceiling in this space. (SRJA 2013)

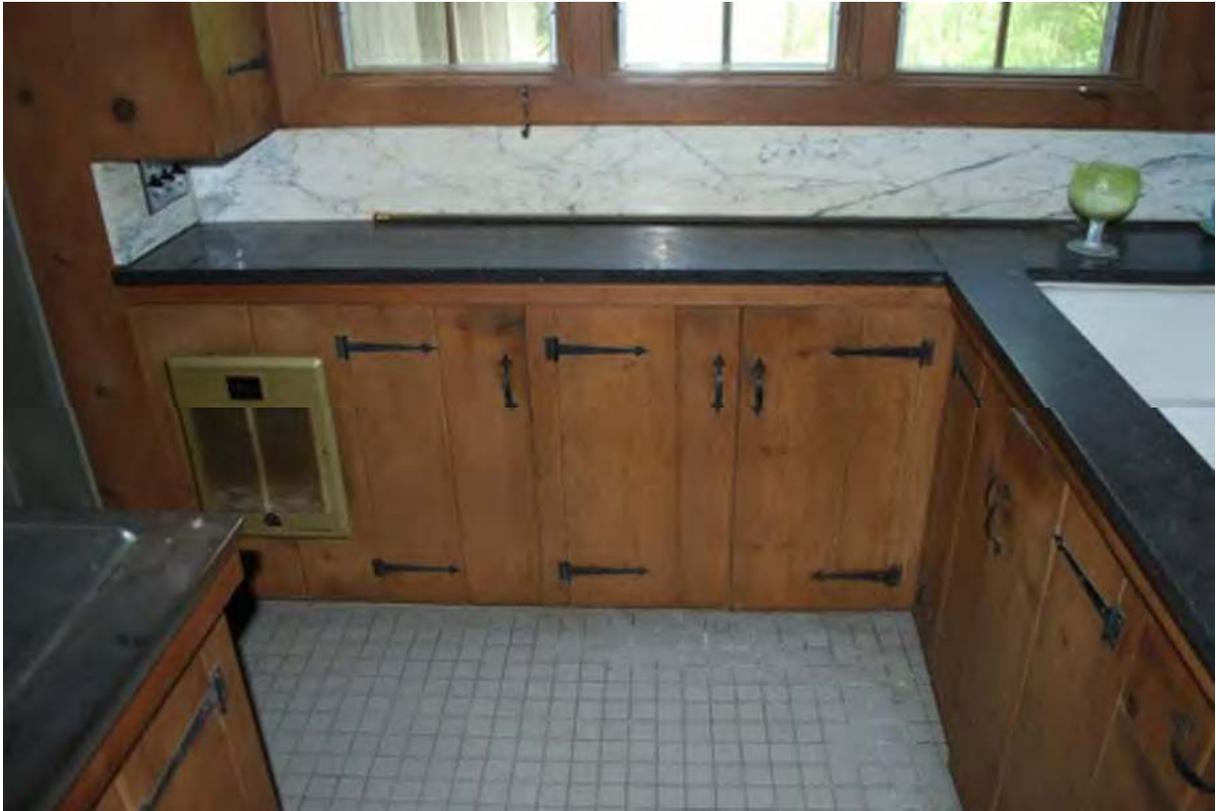
*Figure 15. Kitchen: Clean existing tile floor and re-grout where necessary. (SRJA 2013)*

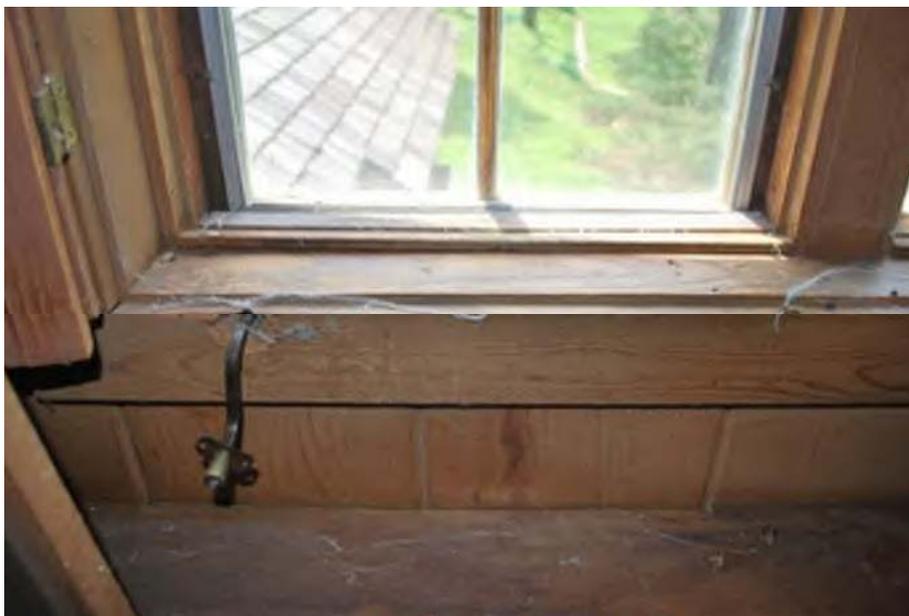
*Figure 16. Second Floor: The casement window crank cover has become unattached and needs to be reattached with longer brass screws. (SRJA 2013)*

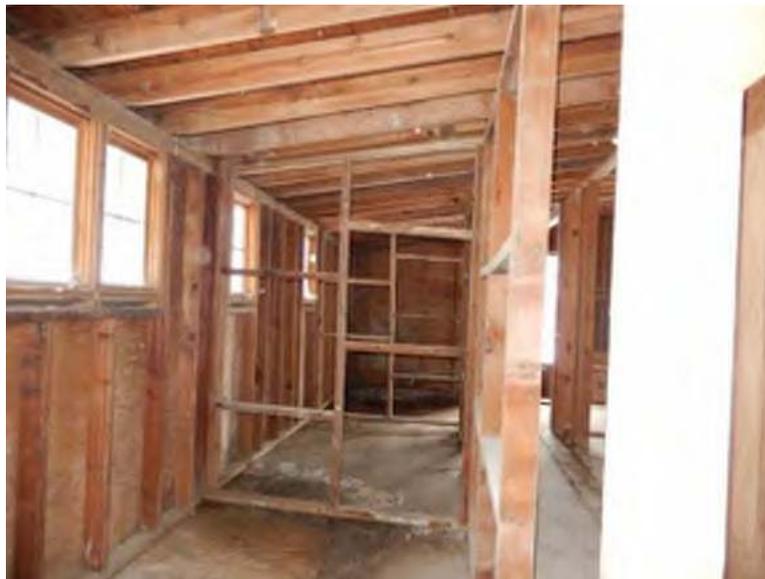
*Figure 18. Phase 2 – South Annex: Replace existing moisture damaged wood studs at east wall and deteriorated floor. (SRJA 2013)*

- *South Annex:* Concerning the east wall - Bearing wall on the east side should be removed and 8" CMU grouted wall put in place from footing to roof joist bearing. Provide foundation drainage board on wall exterior with foundation drain at footing level. Backfill wall with drainage fill to within 12 inches of finish grade. Continue foundation drain towards the south as far as necessary for gravity flow. Work should be coordinated with a French drain planned for installation along the entire east wall of the house. (Figures 18 and 24)

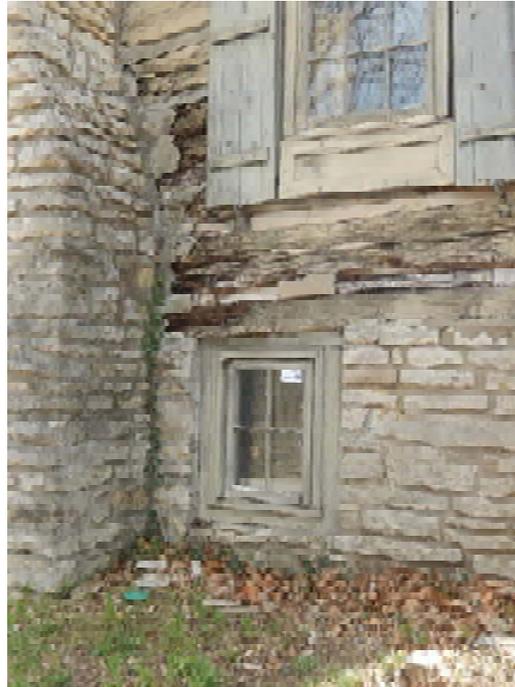
*Figure 19: A portion of the rotten log framing on the west elevation of the residence (SRJA 2015)*

- *Main House:* Remove and replace rotten log framing on the west elevation of the residence. (Figure 19)
- *Main House:* The existing and replacement logs should be treated with an appropriate material to protect against wood rot and insect infestation.

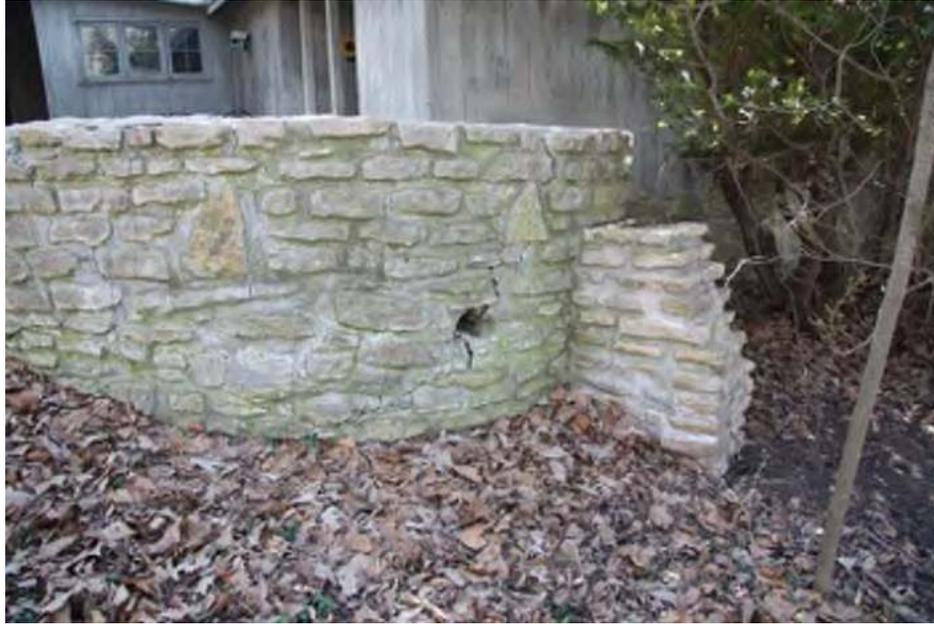
*Figure 21: Existing stone retaining wall on the north side of the patio (SRJA 2013)*

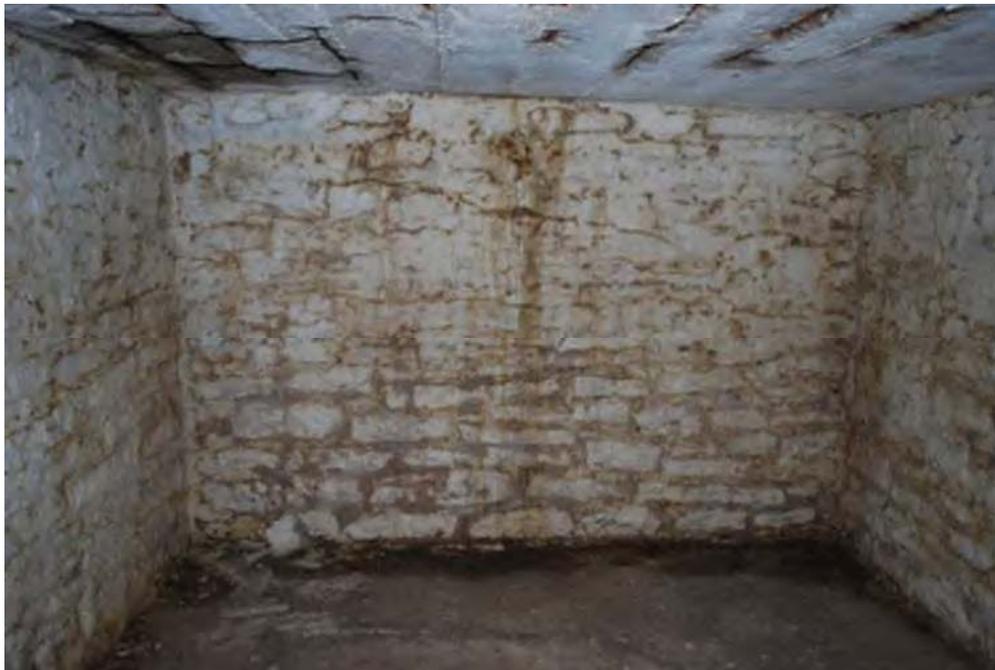
*Figure 22. Interior of root cellar. Note the deteriorated steel reinforcing in the concrete ceiling. (SRJA 2013)*

- *Root Cellar:* Remove the loose concrete and clean and remove rust from the reinforcing steel that is exposed on the ceiling of the root cellar. The steel should be covered with a concrete patch material to provide cover. The top surface of the root cellar should be coated with a waterproofing membrane material to reduce moisture infiltration. (Figure 22)

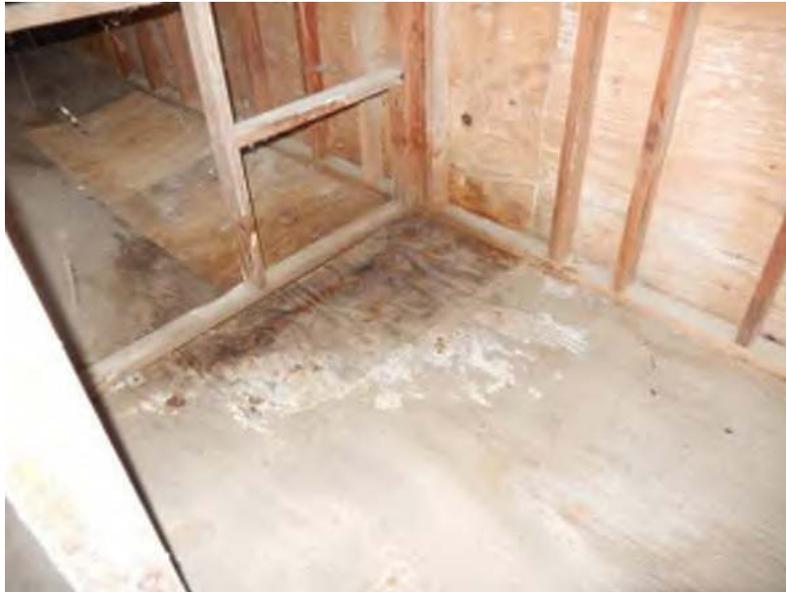
*Figure 23: Deteriorated framing and subfloor at the east wall of the South Annex. (SRJA 2015)*

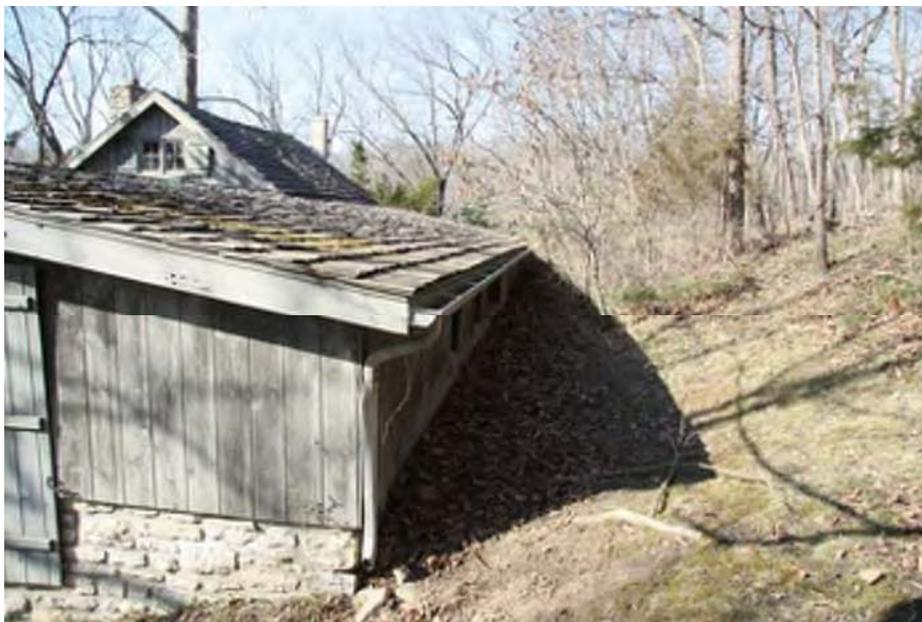
*Figure 24. East elevation of the South Annex. This area requires re-grading and new sub-grade drainage. The gutter needs to be repaired and a volunteer tree growing between the gutter and the roof needs to be removed. (SRJA 2013)*

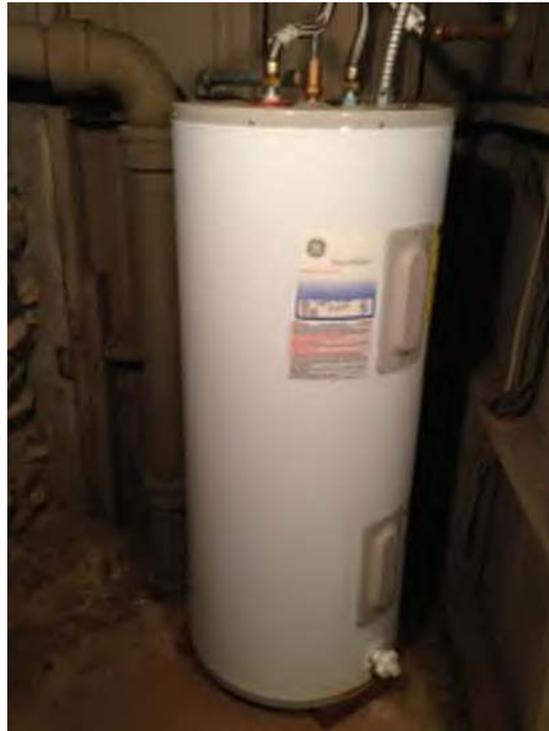
- *Mechanical 004:* The domestic water heater is a GE 40 gallon electric water heater that was installed in 2005 and appears to be in good condition. Replace existing electric tank water heater with point of use water heaters. Replacement is required due to age of existing water heater and need to provide additional space in basement closet for mechanical equipment. (Figure 25)

Figure 25: Existing electric tank water heater to be removed. (WLC 2015)

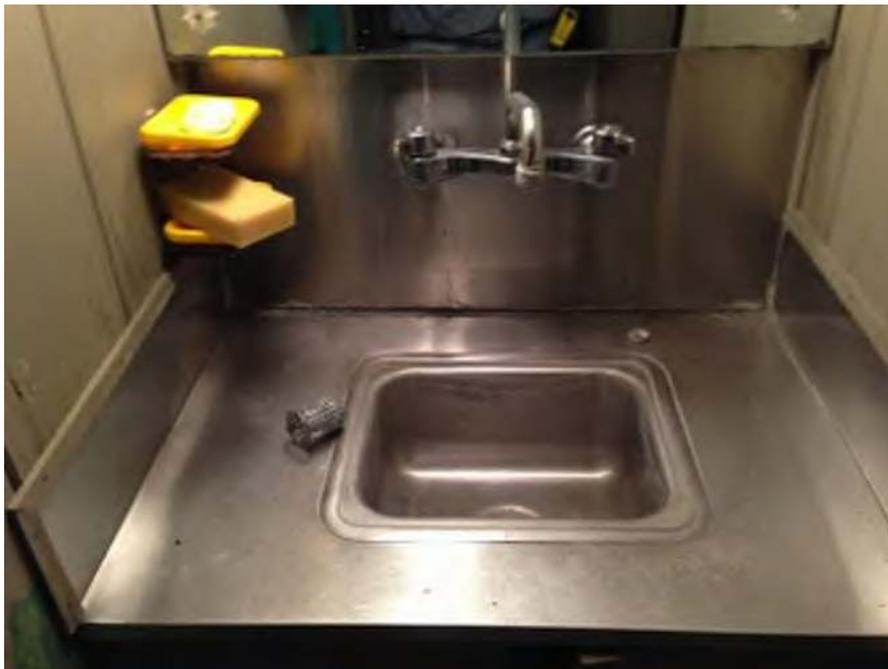
Figure 26: Basement bathroom, existing faucet. (WLC 2015)

- *Bathroom 003, Bathroom 105, Kitchen 108 Faucets and Tailpieces:* Replace existing faucets and tailpieces for the existing restroom lavatories and kitchen sinks due to age and condition of the existing ones. Replace Basement faucet aerator (Figure 26, Figure 27 and Figure 28 )

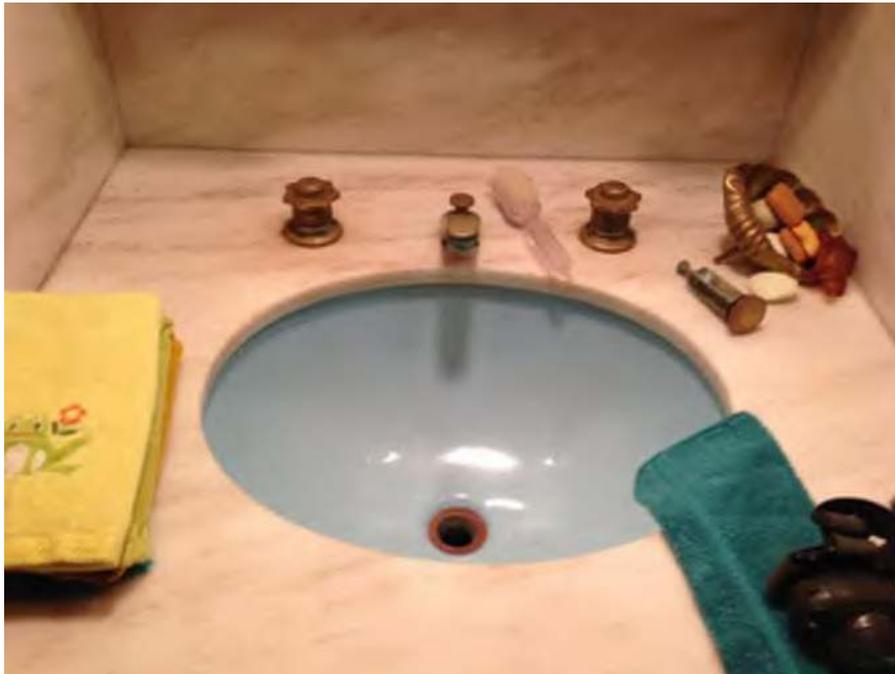
*Figure 27: First floor bathroom, existing faucet. (WLC 2015)*

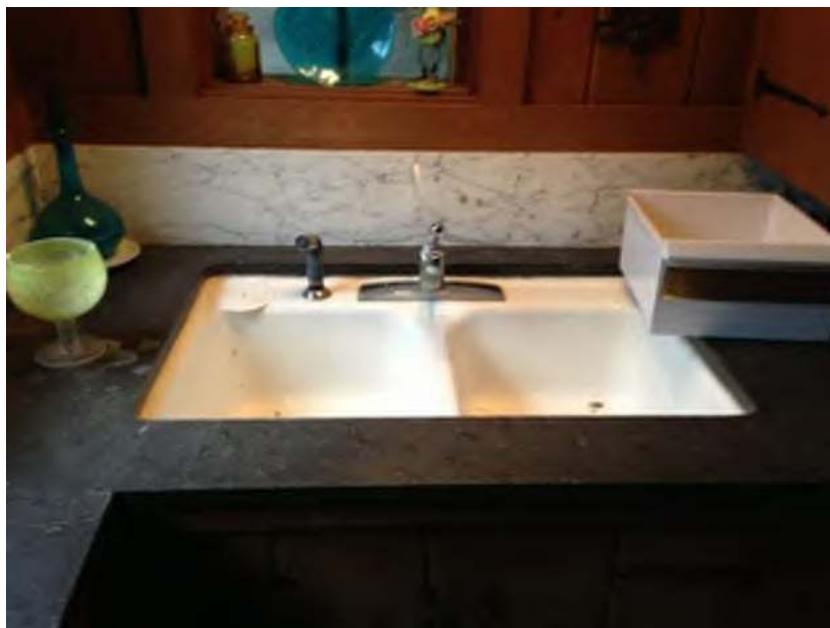
*Figure 28: First floor kitchen, existing faucet. (WLC 2015)*

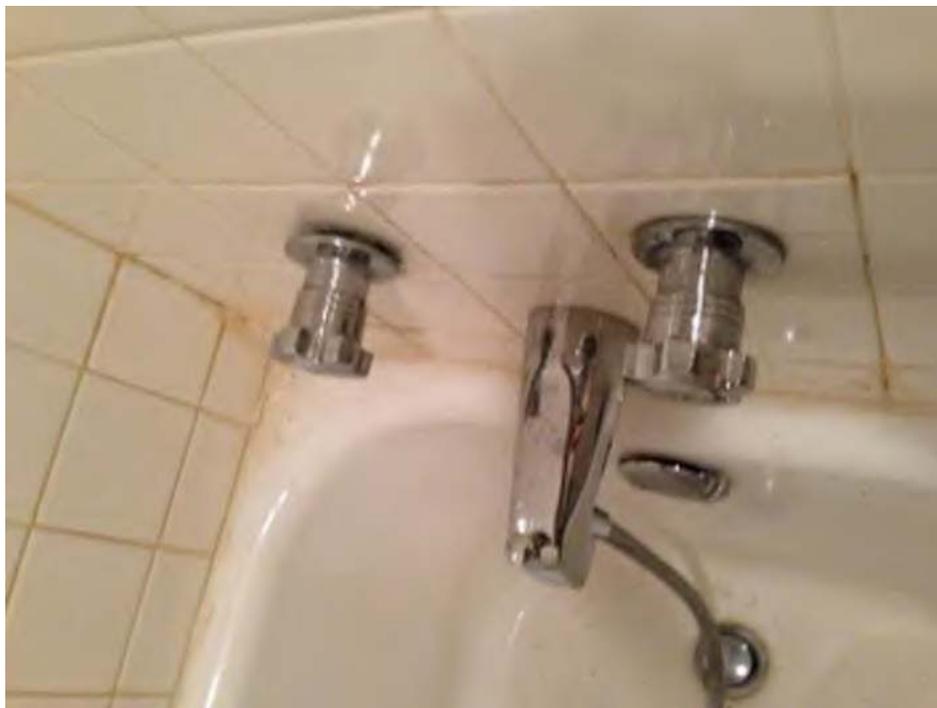
- *Bathroom 105 Tub/Shower:* The tub looks to be in good condition. The faucet appears to be in good shape as well except that the hot water handle is pulled away from the wall a little. Also, the trip lever for drain does not work and the tile needs re-grouting. Adjust faucet handles for the tub so they are tight to the wall. (Figure 31)

Figure 31: First floor bathroom, existing tub faucet. (WLC 2015)

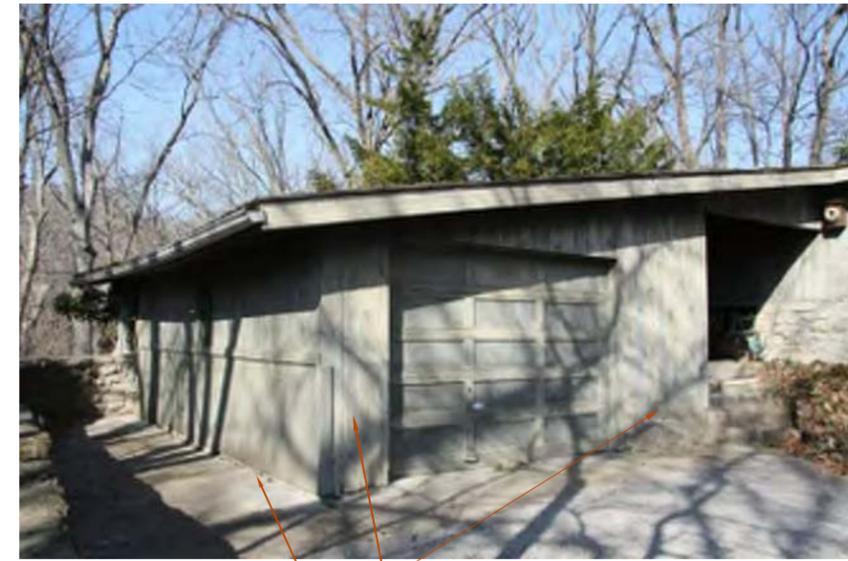
5 GARAGE SOUTH AND WEST ELEVATION

REPLACE WOOD ROT  
CAULK CONCRETE SLAB, TYPICAL
