## Treatment and Interpretive Recommendations

## **Phase 1 – Stabilization of the Existing House:** **Refer to the Phase 1 Treatment Drawings and Product Cut Sheets in the Appendix**

### **Architectural Treatment Recommendations (Figures 1-18):**

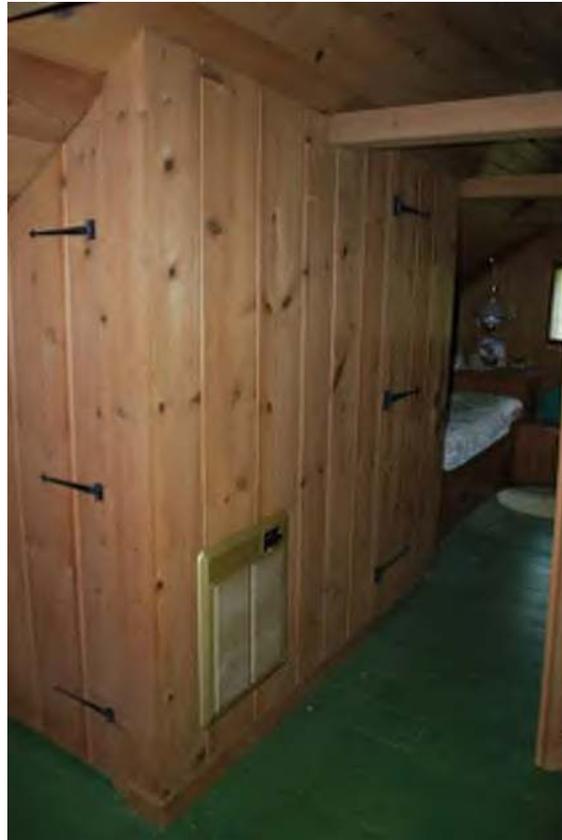
*Figure 17. Second Floor: Location for proposed new HVAC equipment within these closets. (SRJA 2013)*

- *Closet 202, Closet 204:* Install concealed VRF FCU in the existing east closets on the second floor to serve the second floor. The divider wall between the closets will need to be removed and the west closet door will need to be secured shut. Outside air for ventilation will be ducted from a mushroom intake on the roof to the FCU. A digital thermostat will be installed to control the unit. (Figure 34)

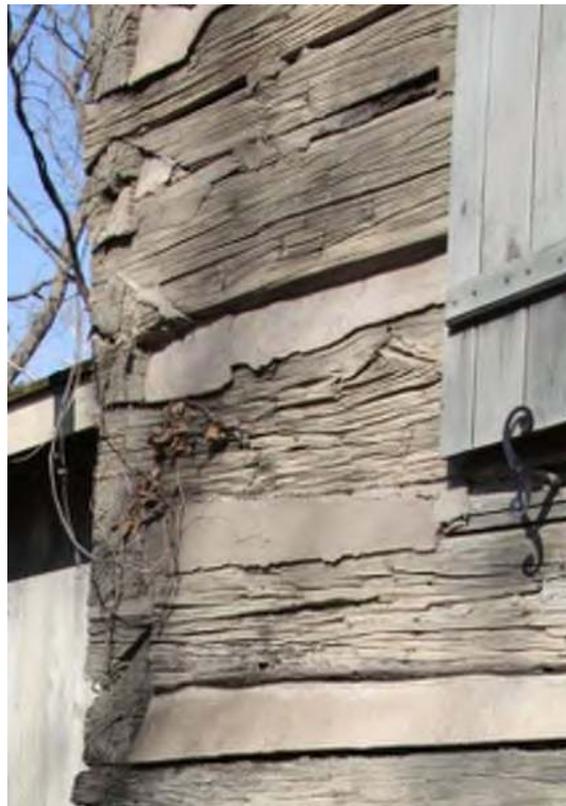
*Figure 19: A portion of the rotten log framing on the west elevation of the residence (SRJA 2015)*

- *Main House:* Remove and replace rotten log framing on the west elevation of the residence. (Figure 19)
- *Main House:* The existing and replacement logs should be treated with an appropriate material to protect against wood rot and insect infestation.

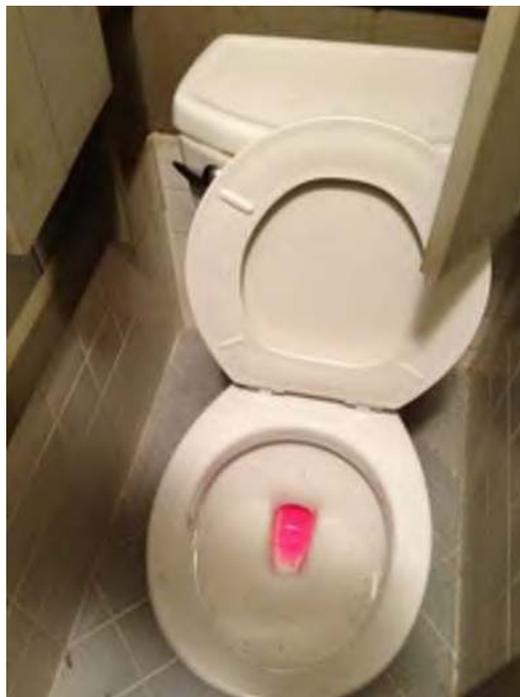
*Figure 29: Basement bathroom, existing toilet. (WLC 2015)*

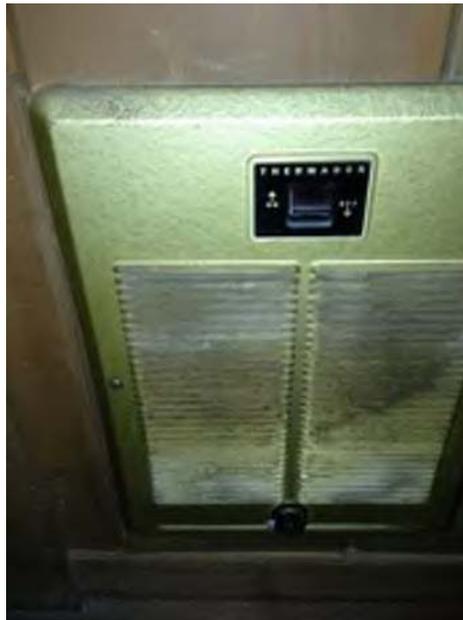
- Some of the wall heaters are non-functional and the functionality could not be confirmed, as they may have been turned off at the panel board. The wall heater does not work in the phone nook. Even though some of the heating system works, it all appears to be of 1960's ± era and are well past their useful life. The combination light/heater/exhaust fan in bath tub room appears to work fine. There is no heating in the lavatory room except possibly a heat lamp. The toilet room has no heat. The wall heater in the Mud Room appears to work fine (Figure 32).

Figure 32: Electric Heater

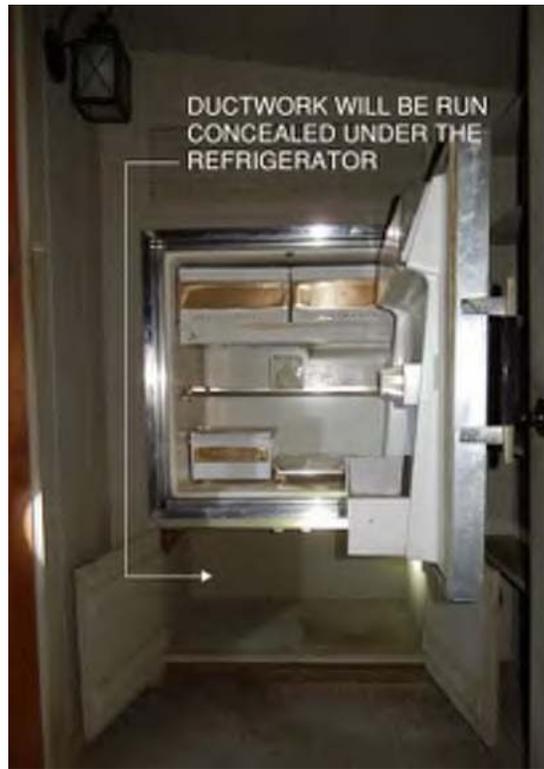
Figure 33. Second Floor, East Closet (SRJA 2015)

- *Mud Room/Entry 110:* Install concealed VRF fan coil unit (FCU) in the Mud Room to serve the Mud Room, Kitchen and Breakfast Nook. Ductwork will be run concealed within the surrounding refrigerator and cooktop casework to serve the Kitchen and Breakfast Nook. Outside air ductwork for ventilation will be routed from a louver in the west wall of the Mud Room to the architectural enclosure for the FCU. A digital thermostat will be installed between the Breakfast Nook and Kitchen to control the unit. (Figure 33)

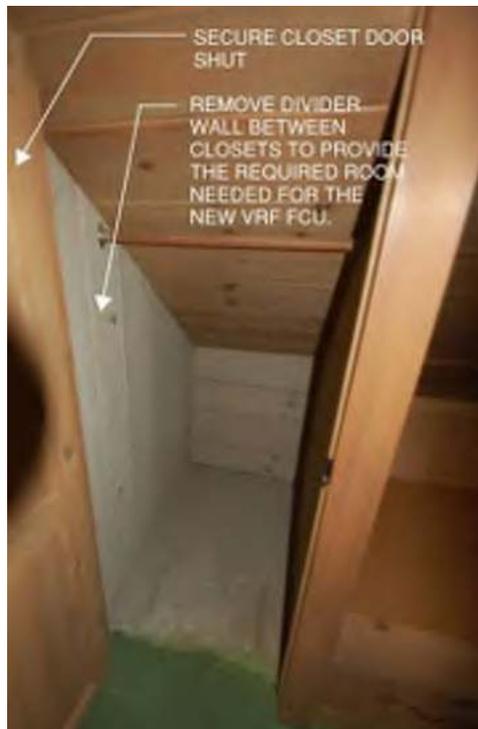
Figure 34. Second Floor, East Closet (SRJA 2015)

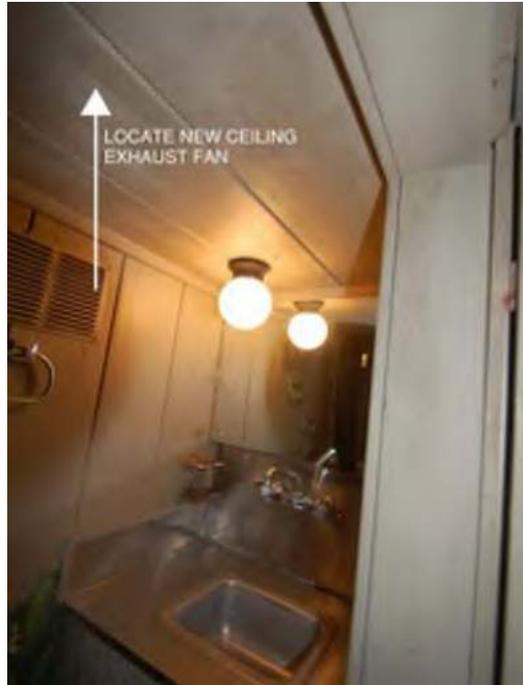
- *Bathroom 003:* The basement restroom is not exhausted and has no exterior window. Since neither exists the installation is in violation of present codes. A ceiling exhaust fan with integral exhaust grille will be installed in the basement restroom as required by code and ducted to a flapper damper on the west wall of the basement. (Figure 35)

Figure 35: Location for new ceiling exhaust fan in basement (SRJA 2015)

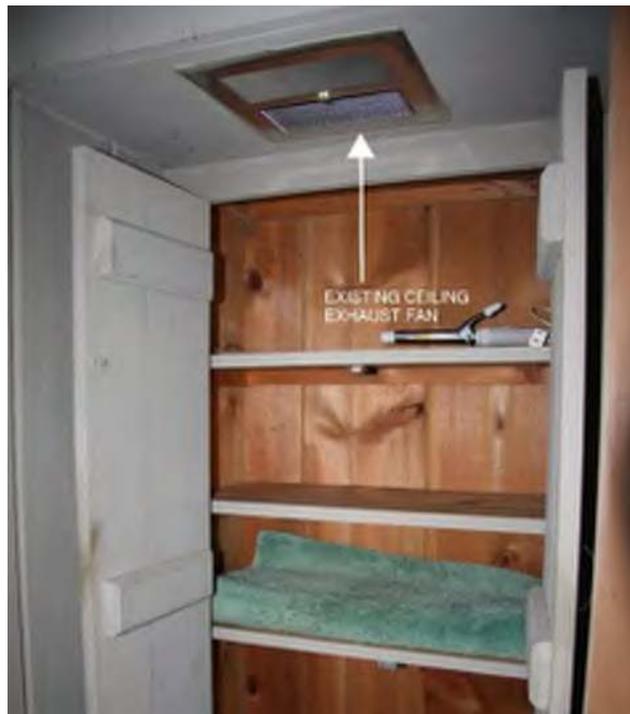
- *Bathroom 105:* The existing ceiling exhaust fans serving the first floor restroom will be cleaned up and refurbished as it is in relatively good condition. (Figure 36)

Figure 36 Existing Ceiling Exhaust Fan

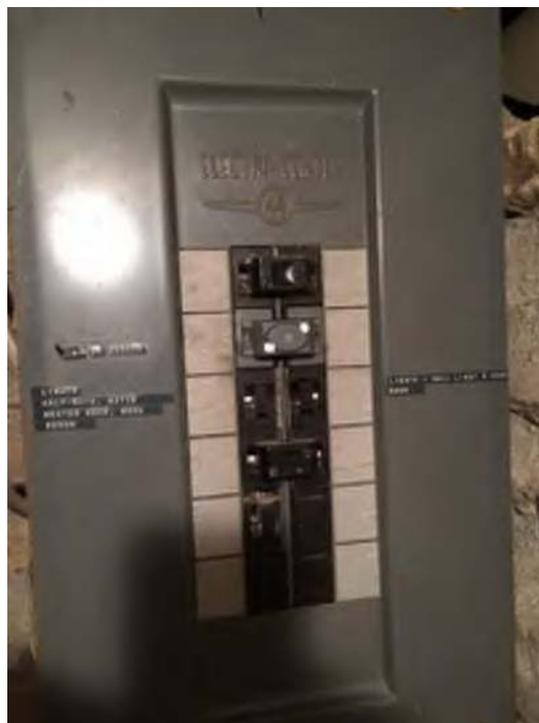
Figure 37: Basement panel (WLC 2015)

- Due to the new load that is planned for the mechanical system, an upgrade from the existing 200 amp electrical service will be necessary. We are recommending that the recently renovated electrical service be upgraded to a 400 amp service. (Figures 37- 40)

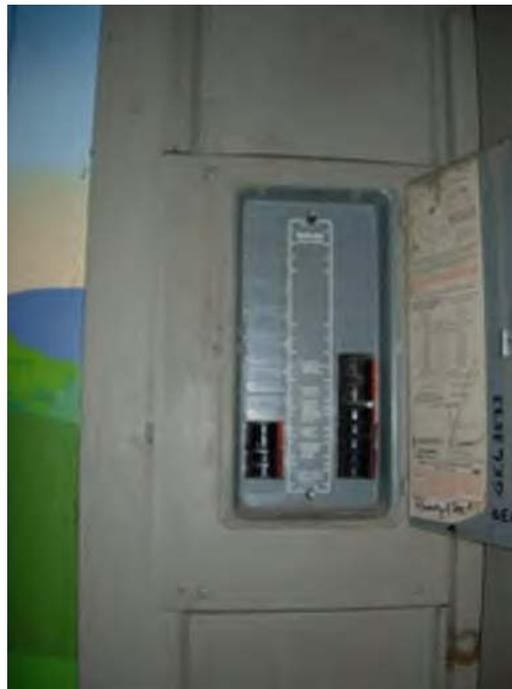
Figure 39: South Mud Room panel (WLC 2015)

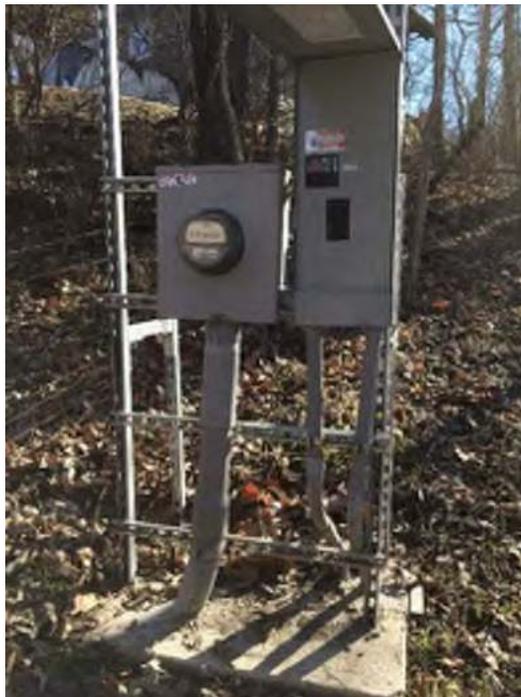
Figure 40: Existing electrical service (WLC 2015)

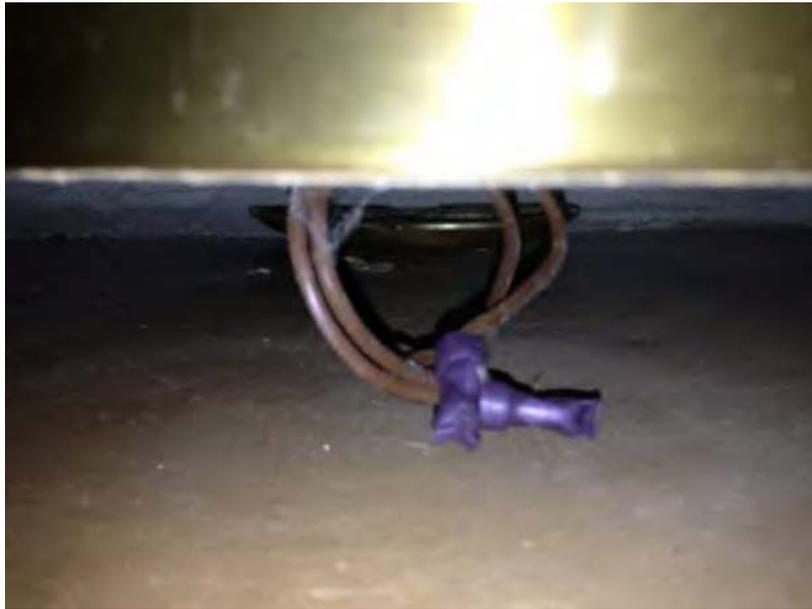
- It was observed that some of the lamps are hard wired without junction boxes. This is a code violation and a fire hazard. Junction boxes should be installed to protect the wiring connections. (Figure 41)  
Many of the existing light fixtures are not controlled by wall switches. Where this occurs the light fixtures are controlled from switches mounted directly on the light fixtures. This is not unusual for older buildings such as this, but it is not a standard practice today. We believe it is not standard today because it can be difficult to find a switch in low level lighting conditions.

*Figure 41: Wiring connections below a lamp (WLC 2013)*

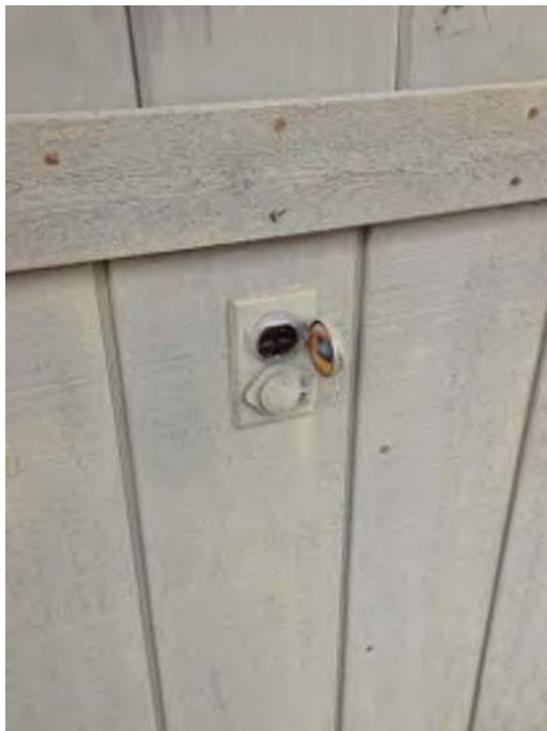
- Mechanical 004: In the basement a convenience receptacle was observed in the joist space between the basement and the floor above, near the panel board in Mechanical 004. This receptacle is noted to be replaced with GFCI type to meet present code.
- All existing exterior receptacles are noted to be replaced with a GFCI receptacle as required by present codes. Three existing receptacles installed in the garage are shown to be replaced with GFCI type as required by present codes. (Figure 42)
- All of the convenience receptacles that were observed had ground pins for the use of grounding type plugs on devices. Spacing of convenience receptacles does not meet present electrical codes. This is understandable due to the age of the cabin.

*Figure 42: Exterior Receptacle (WLC 2013)*

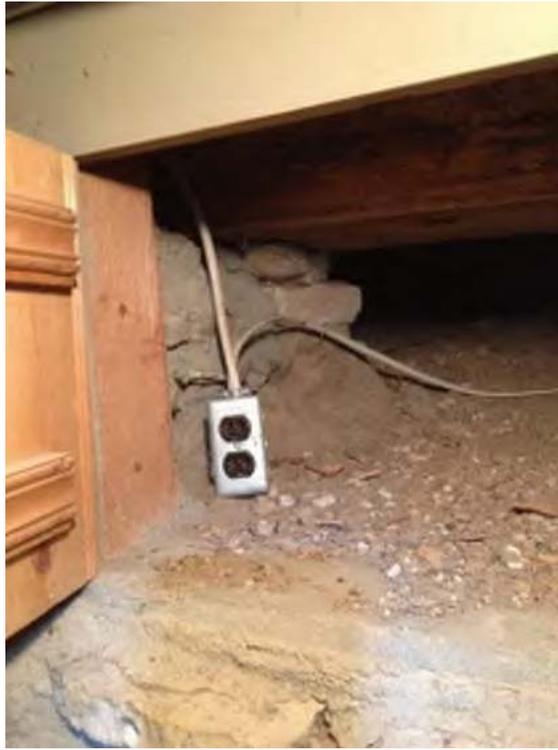
- *Mechanical 004:* In the basement near the panel board that is located in Mechanical 004 there is some wiring that is insulated, but is not covered with its protective jacket. This is a code violation and is required to be replaced or other corrective action taken. This is a potential fire hazard. This wiring is noted to be intercepted in new junction boxes. (Figure 37)
- *Crawl Space & Basement:* In the basement some loose wiring was observed that is in the joist space between the basement and the floor above. All wiring should be properly supported in crawl space (Figure 43)

*Figure 43: Unsupported receptacle and wiring in the crawl space (WLC 2013)*

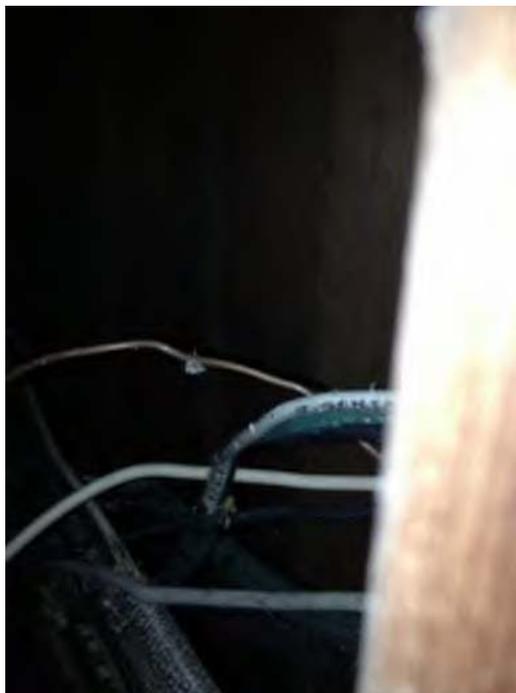
*Figure 44: Wiring without protective jacket (WLC 2013)*

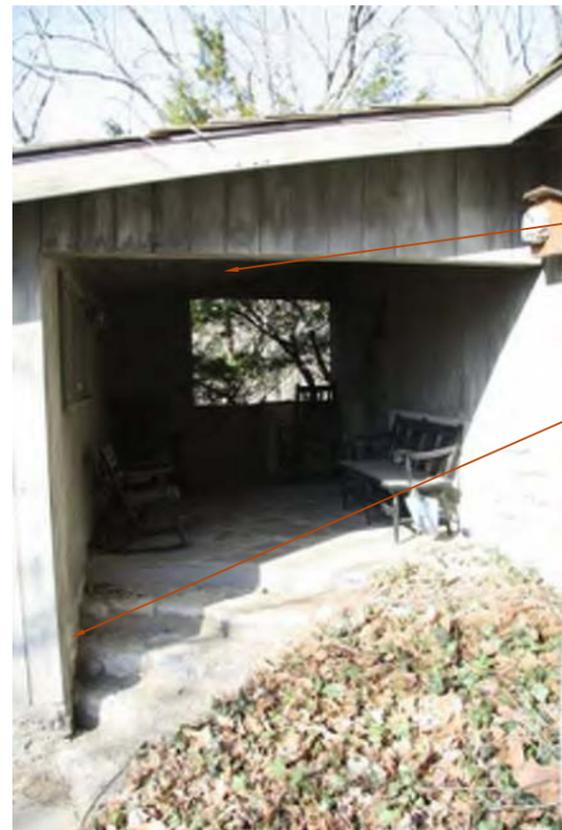
MONITOR GAP IN CEILING

REPAIR WOOD ROT

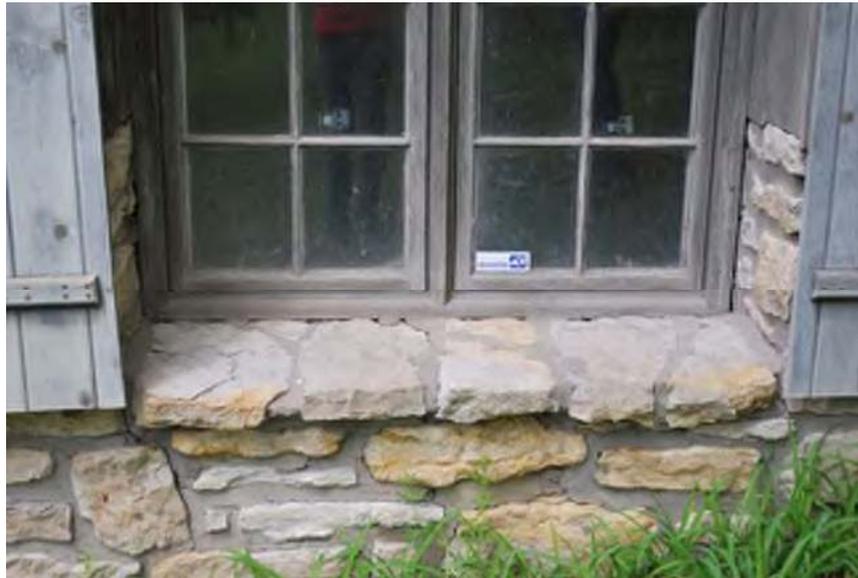
Figure 45. Phase 2 – Annex/Addition: Demo existing stone sill. (SRJA 2013)

- Demolish interior framing and install new framing, per the Structural Recommendations below.
- Frame new Mechanical Room.
- Remove existing window on the South Elevation of Annex. Demo existing stone sill down to finish floor. Install new sill, aluminum door, and side light. Repair stone jambs. (Figure 45)

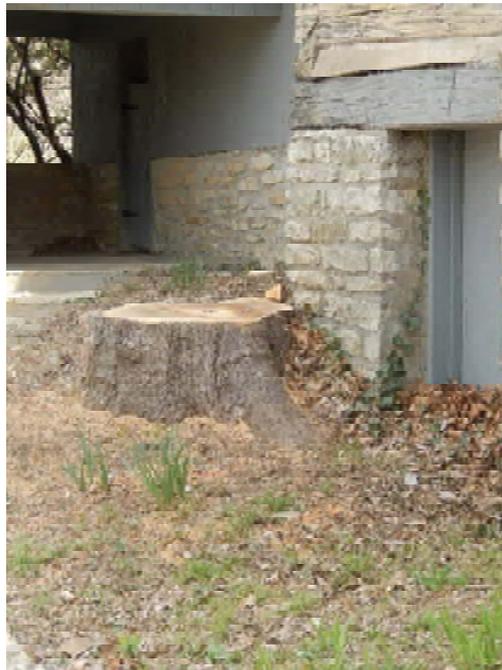
Figure 46: Stump of large Sycamore tree (SRJA 2015)

- *Main House:* Remove root system for sycamore tree where it undermines the foundation for the residence. This can wait until the roots begin to rot so that removal requires less force and will pose less of a risk for damaging the foundation wall. After roots are removed, pour a flowable fill material under the foundation wall to provide support. (Figure 46)
- Install new 8" LVL beam installed under ceiling framing to replace existing stud wall.
- Install new 2x8 header over new door opening on south wall. Provide (2) 2x8 with double full height studs and cripples on either side of opening.
- Install 4x4 structural post furred out with wood. Prime and paint. (Figure 47)

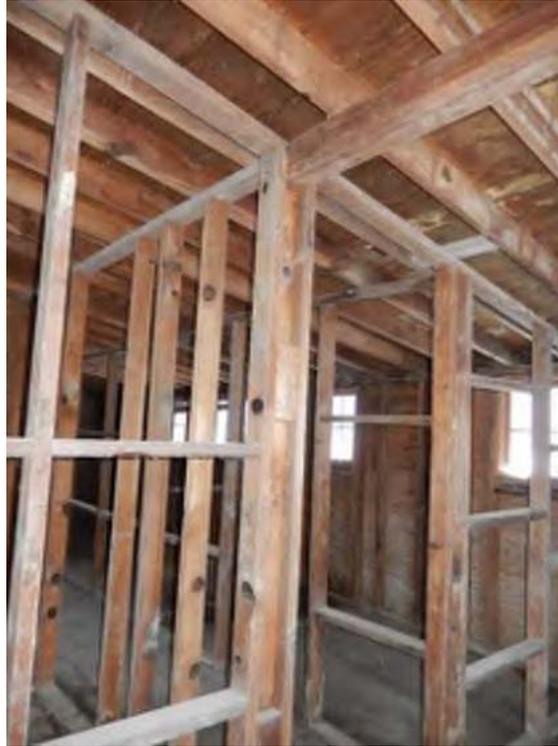
Figure 47: Existing column in Addition 101. (SRJA 2015)
